PROPERTY CONDITION ASSESSMENT
OF
WORLD TRADE CENTER PORTFOLIO

FIVE WORLD TRADE CENTER

Re: Due Diligence Physical Condition Survey
World Trade Center
New York, New York

REPORT OF
DUE DILIGENCE PHYSICAL CONDITION SURVEY
WORLD TRADE CENTER

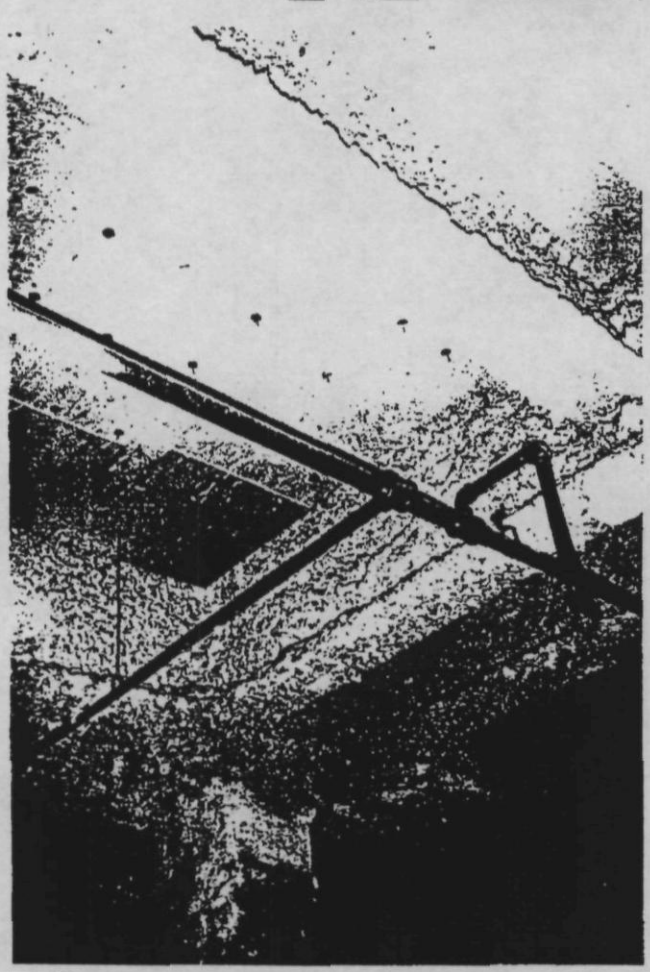
Photograph 2

Existing structure at 8th floor below the MER. Spray-applied fireproofing and rigid panel sound insulation are visible

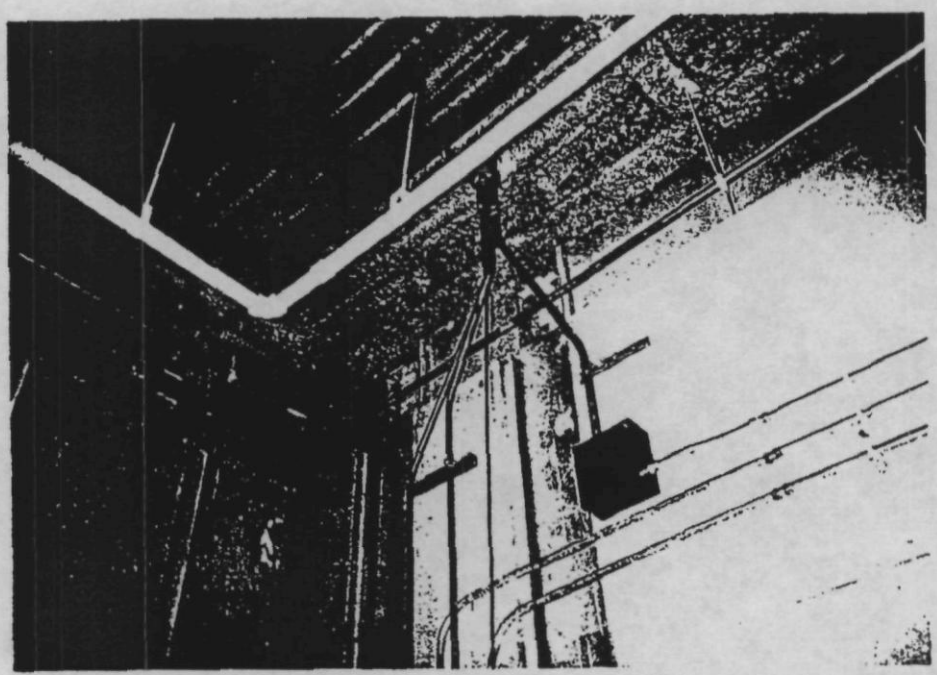
Photograph 4

Roof deck visible at 9th Floor MER Customs House

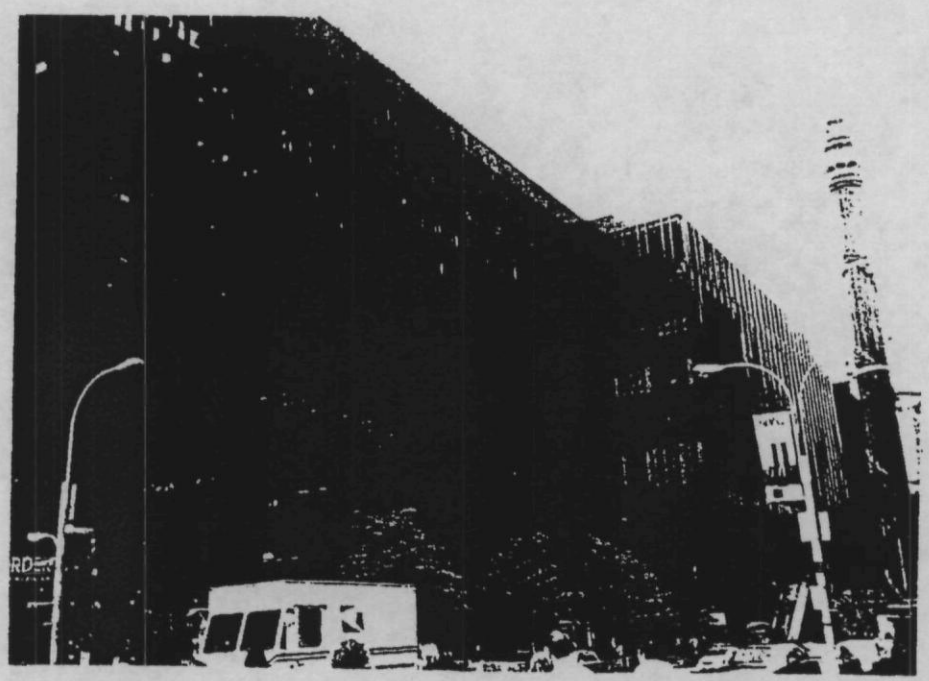
Photograph 9

North elevation

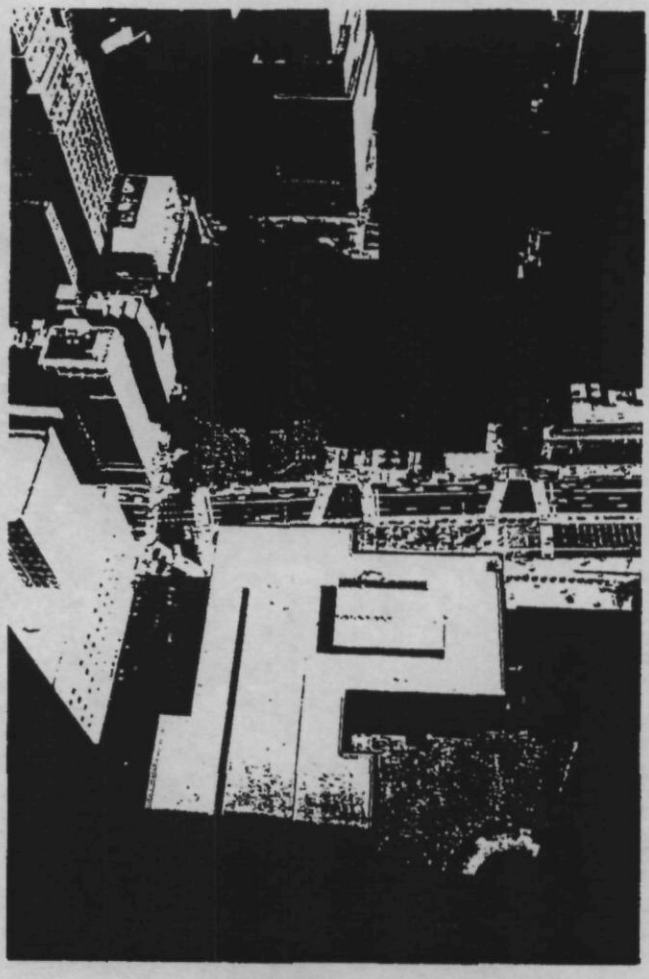
Photograph 11

Roof layout overview from tower

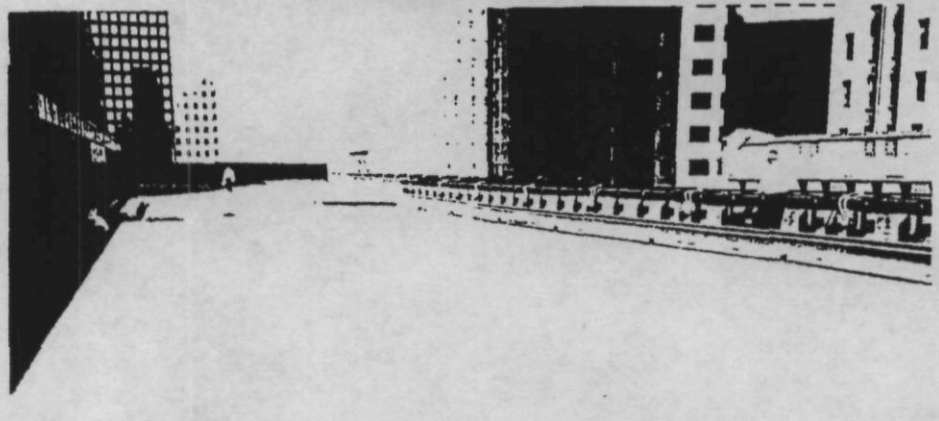
Photograph 12

Main field of roof with mechanical penthouse, window washing rig track and parapets visible

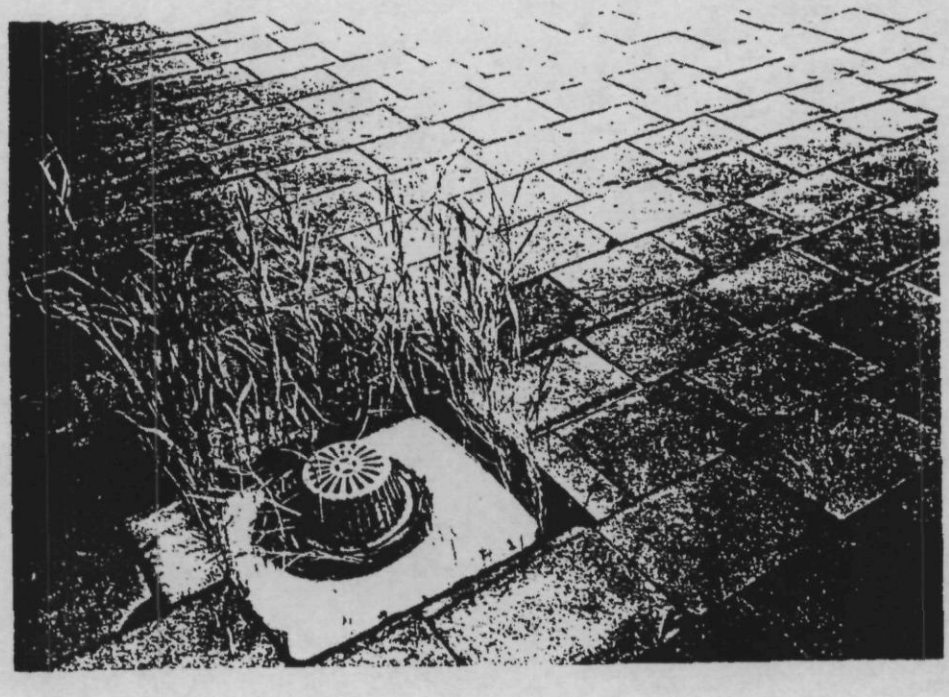
Photograph 13

Detail of roof drain with vegetation growth supported by the moisture held in paver backing

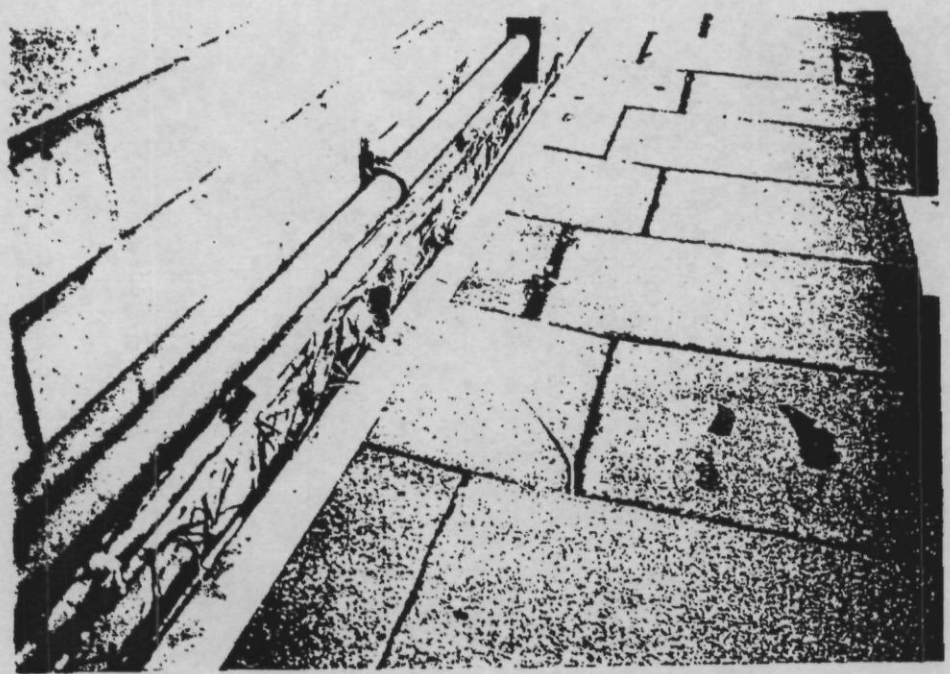
Photograph 15

Penthouse roof with pavers removed for patching of membrane

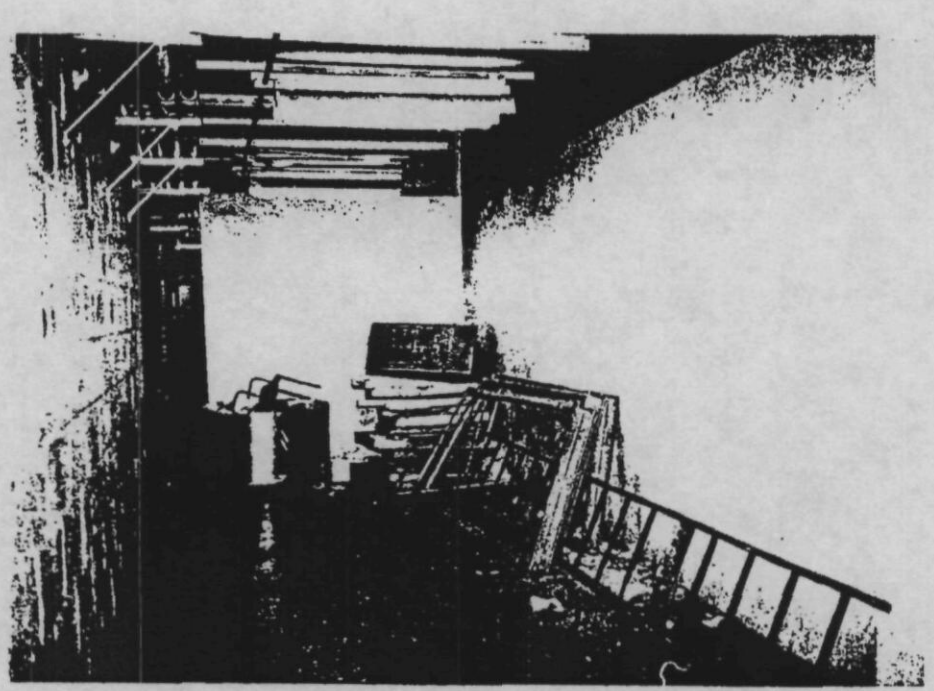
Photograph 28

Stored debris blocking corridor on B1 level

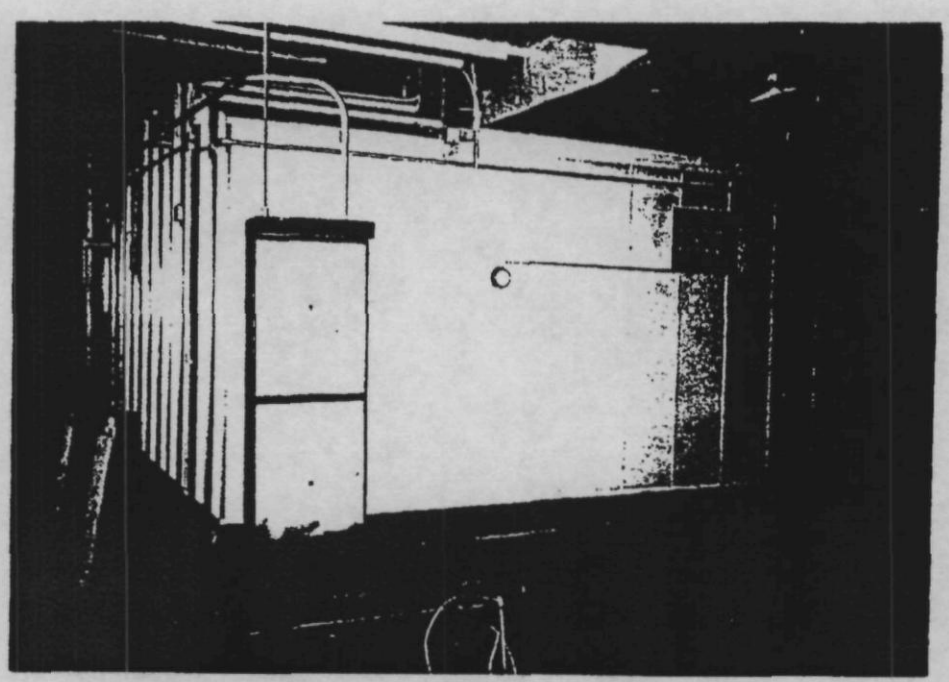
Photograph M1

Typical air handling unit located in the 9th floor mechanical room

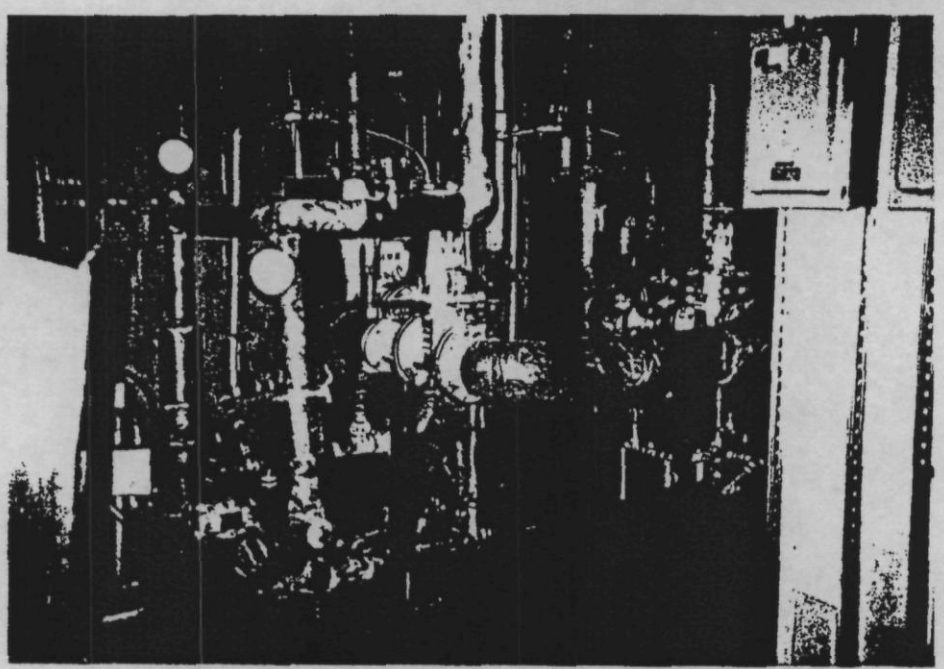
Photograph M11

Standpipe riser with sprinkler supply, and flow and tamper switches
